ACOUSTICAL AND VIBRATIONAL STUDIES
RELATING TO AN OCCURRENCE OF SONIC BOOM INDUCED
DAMAGE TO A WINDOW GLASS IN A STORE FRONT

By Richard L. Lowery and Don K. Andrews

Prepared under Contract No. NAS1-5813 by
ANDREWS ASSOCIATES, INC.
Oklahoma City, Oklahoma

GPO PRICE \$ NATIONAL AERONAUTICS AND SPACE ADMINISTRATION

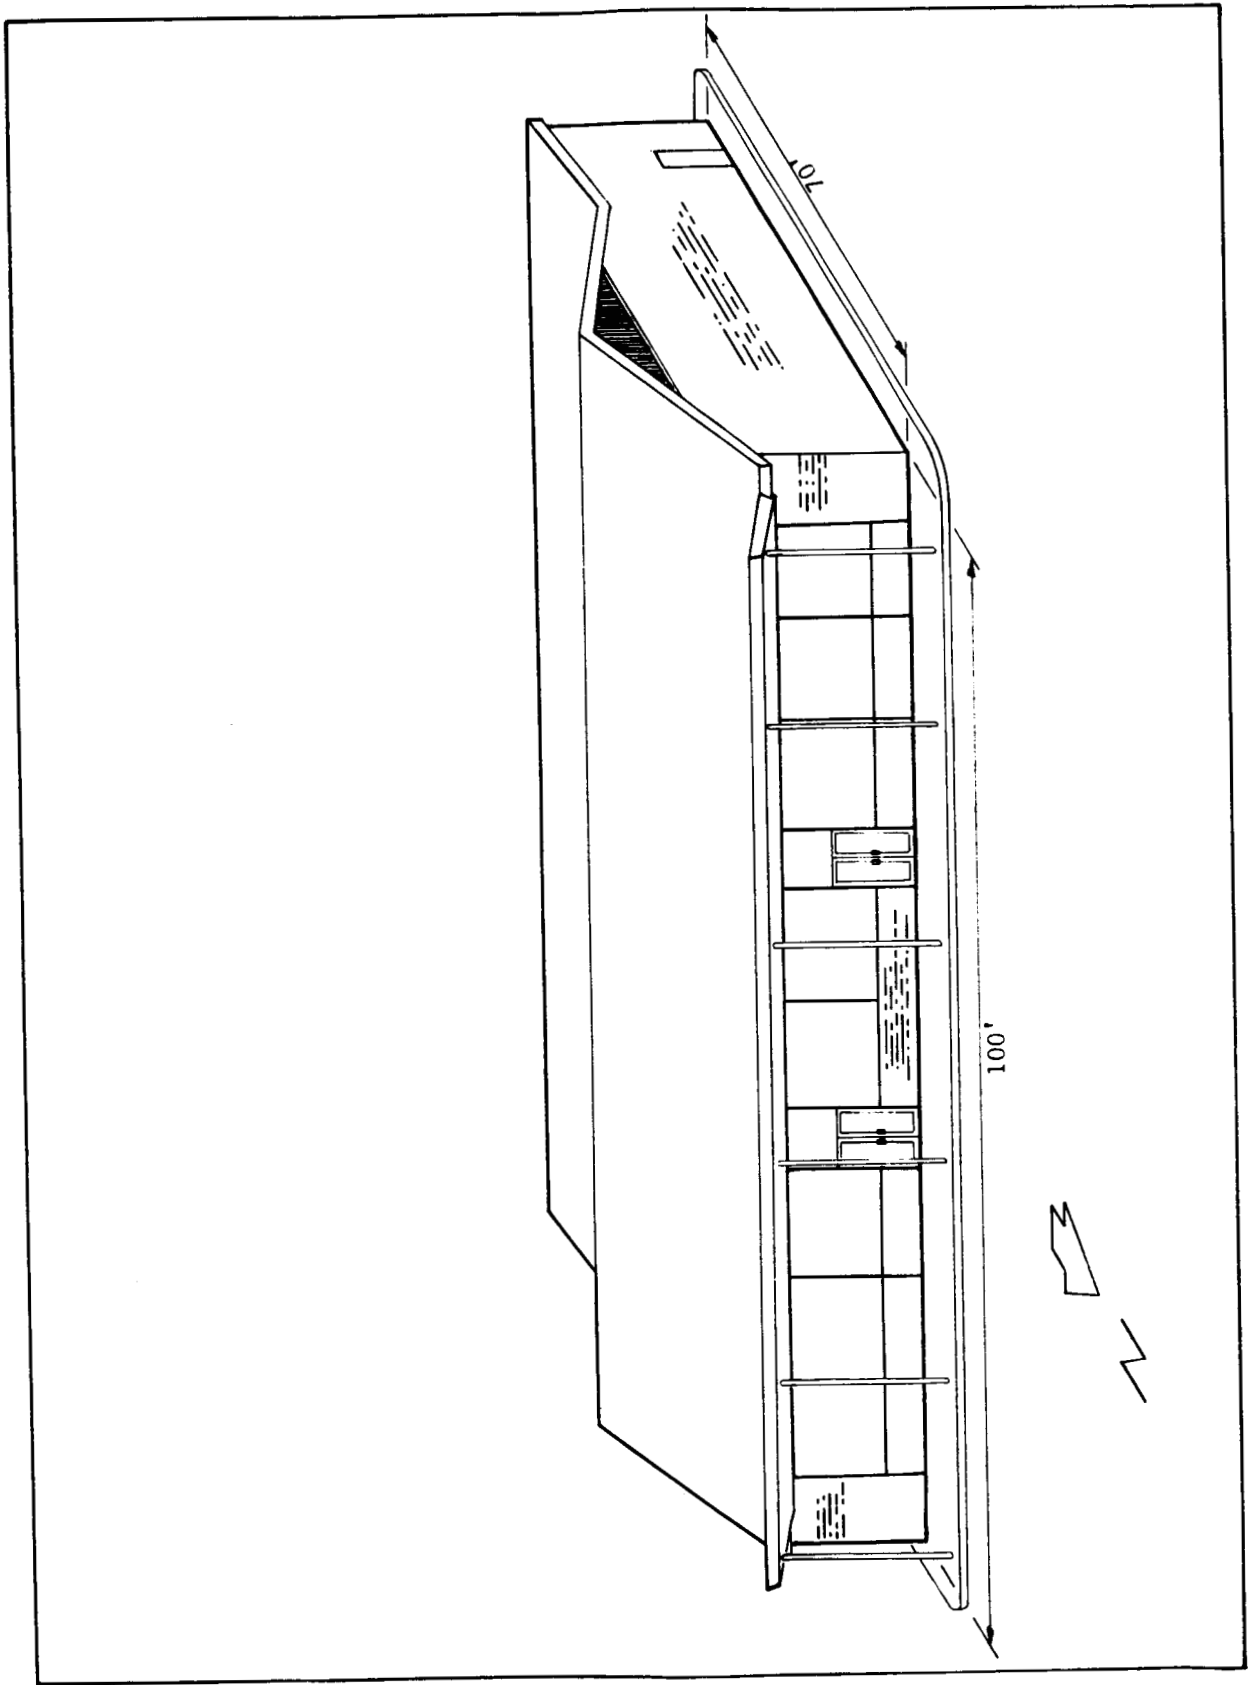
Figure 5 - Exterior configuration of store building.

Exterior configuration of the store building is shown in Figure 5. The interior is divided into a main room and a U shaped stock room as shown in Figure 6. The two separate volumes are connected by six open passage-ways. The separating wall between the stock room and main room is a curtain wall which is plywood on wood studs. It is doubtful the partition is even moderately airtight.

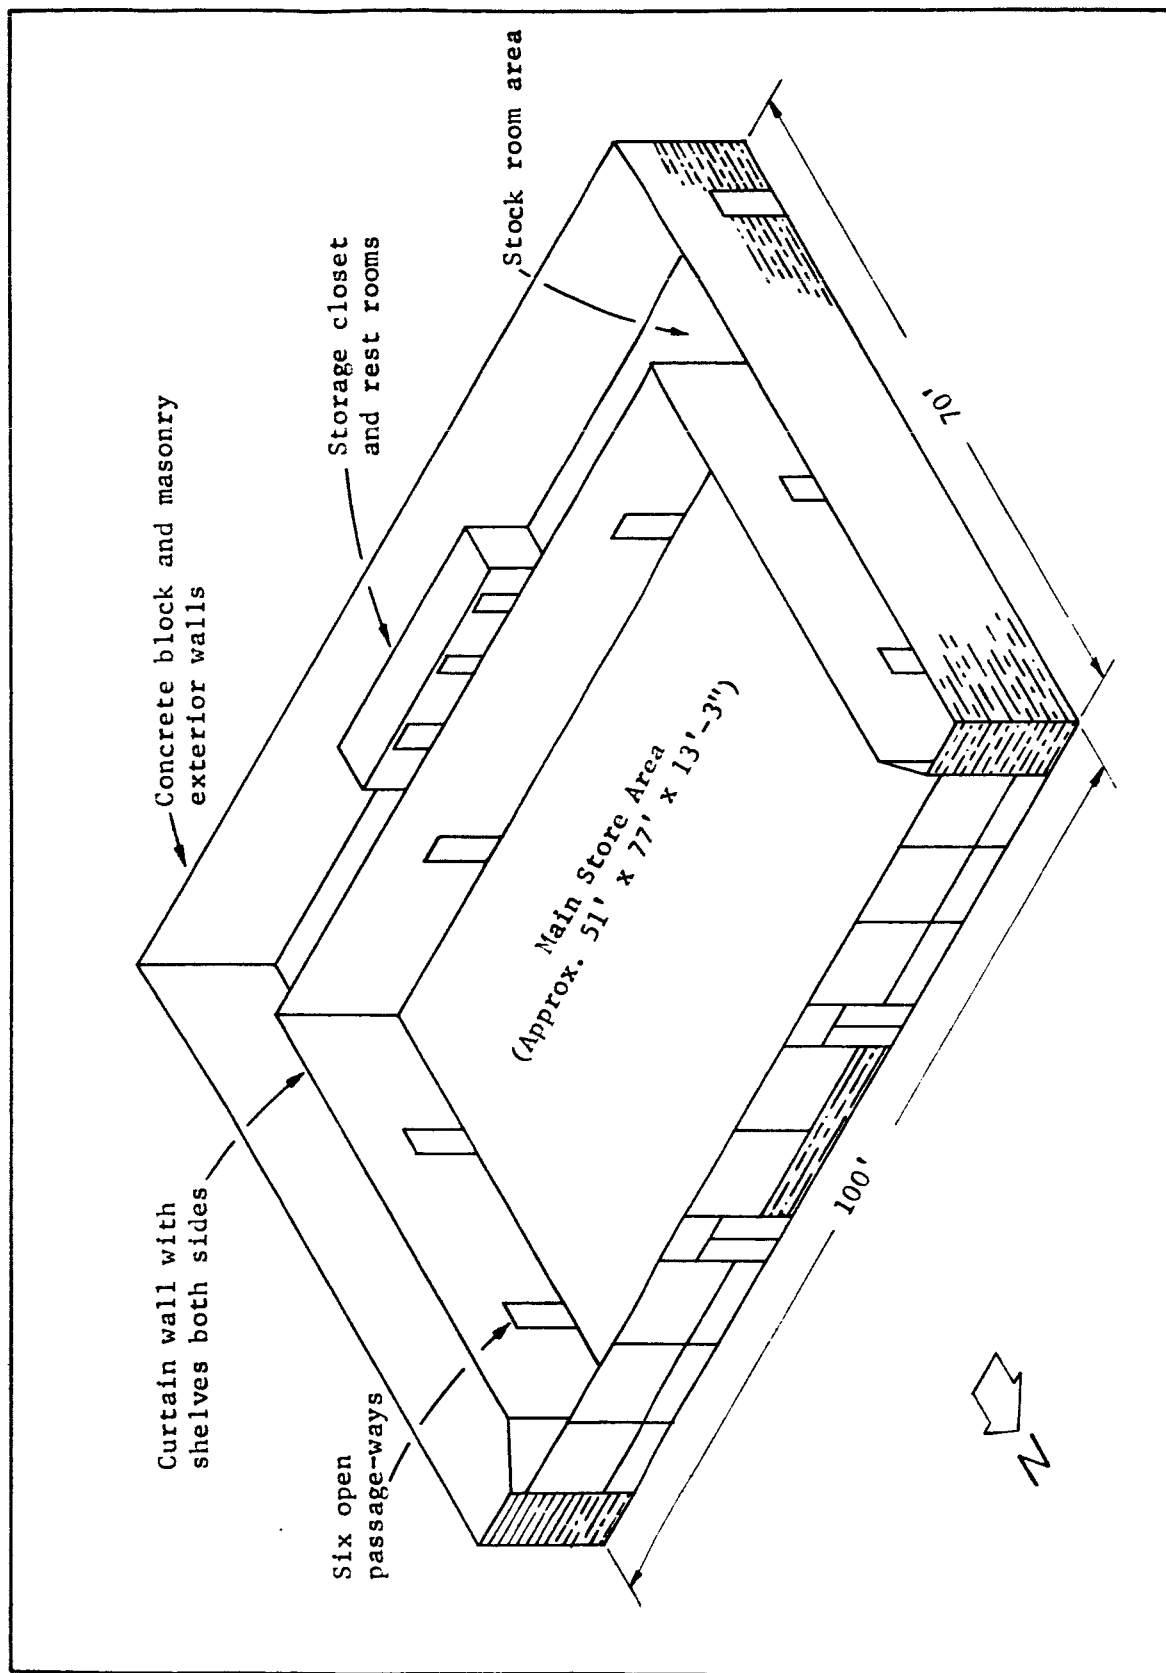
Figure 6 - Interior configuration of store building.

The building proper is essentially airtight with the exception of an air-conditioning inlet duct of approximately 3 square feet at the rear of the building and two small ventilating openings in the louvers in the gables of the roof. The volume inclosed between the roof and the ceiling joists communicates with the stock room through a 1 inch gap between the masonry walls of the building and the sheetrock ceiling. Hence, the ceiling is not connected to the walls at the east and west ends of the building, but is partially supported by the curtain wall separating the stock room from the main room.

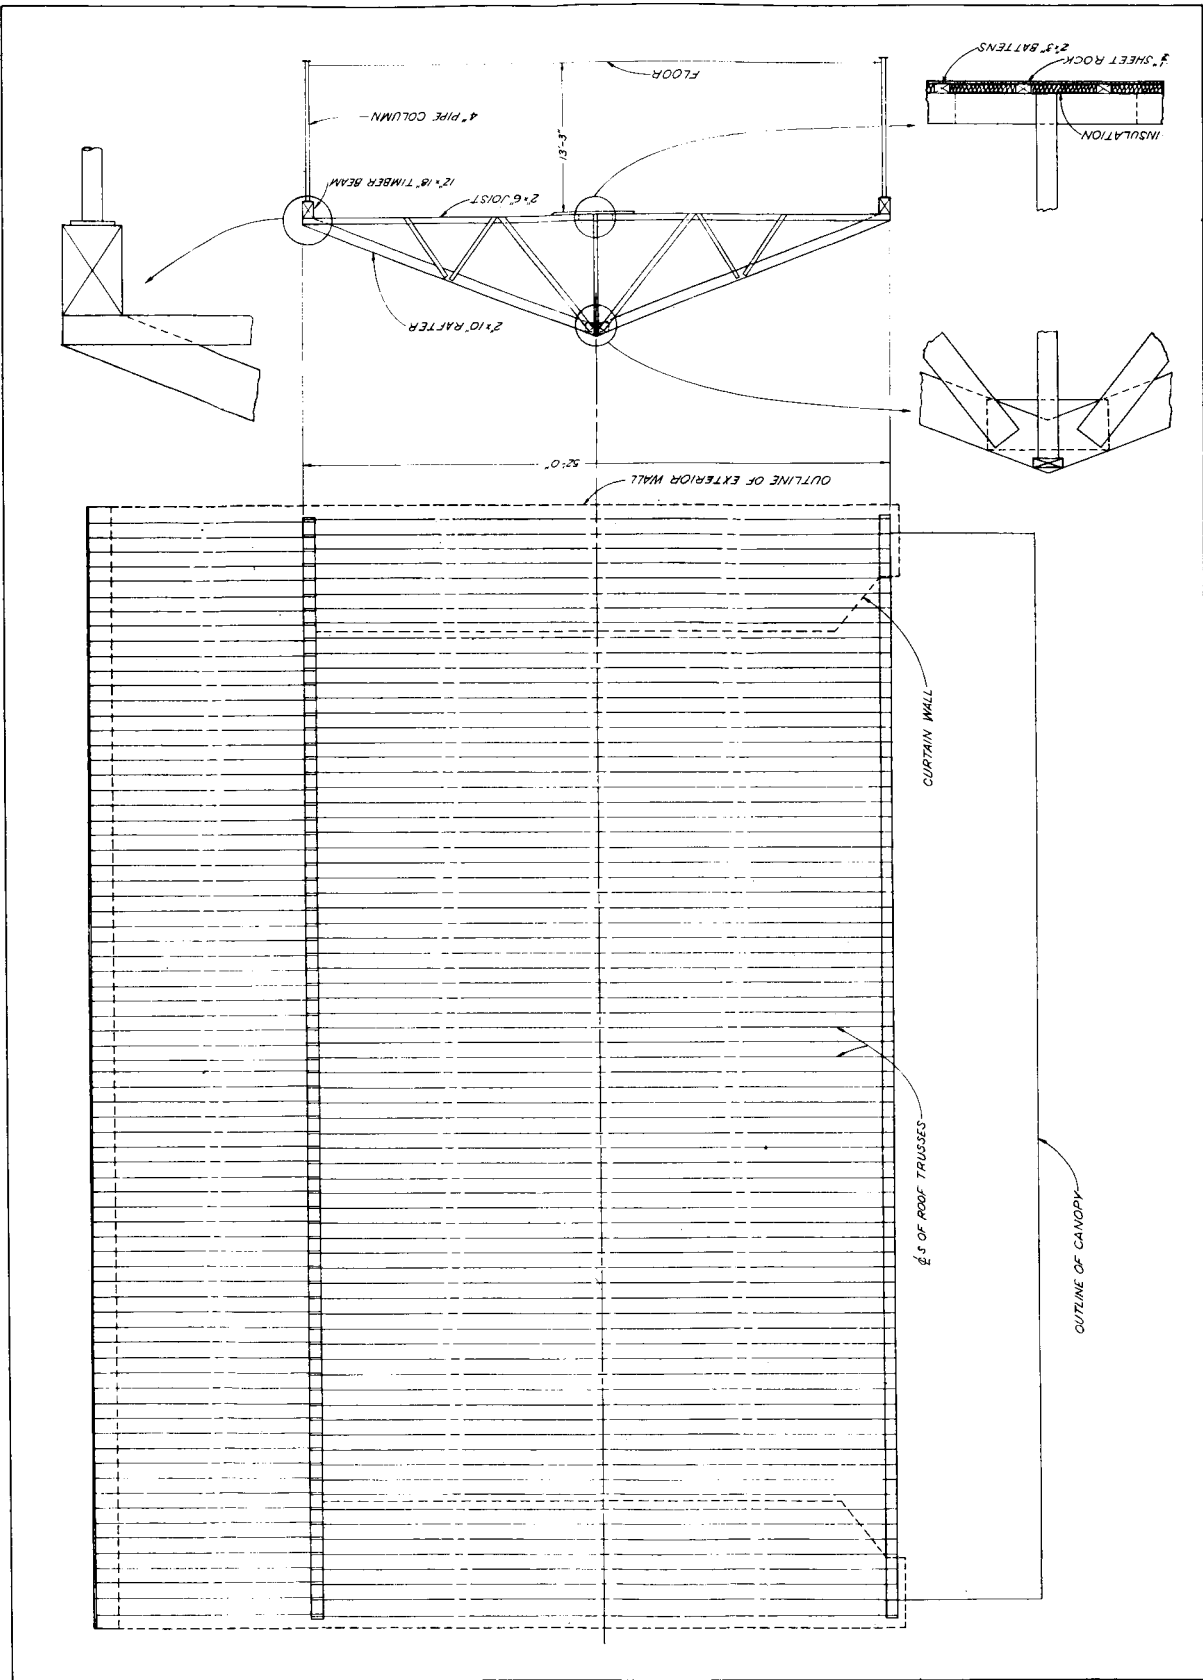
Figure 7 - Details of wood truss structure over main store area.

The ceiling-roof assembly consists of a number of identical wood trusses with sheet rock nailed to battens which, in turn, are nailed to the wood ceiling joists as shown in Figure 7. The trusses seem to be very stiff, although they are probably somewhat longer than would normally be used in general architectural practice. The span of each truss is approximately 50 feet, as shown in Figure 7. Measurements made with respect to the floor of the main area indicate that there is at least 1 inch of sag at the center of the room. There are several relatively severe dry wall cracks running east-west in the ceiling of the main room at the approximate center of the 50 foot span. These cracks have been repaired on several occasions but seem to be re-opening again. There is evidence that additional bracing was put into the truss work over the center of the main area in an effort to alleviate this problem. Periodic testing of the wood moisture content of the ceiling-roof structure was maintained during the field testing phase of this study.

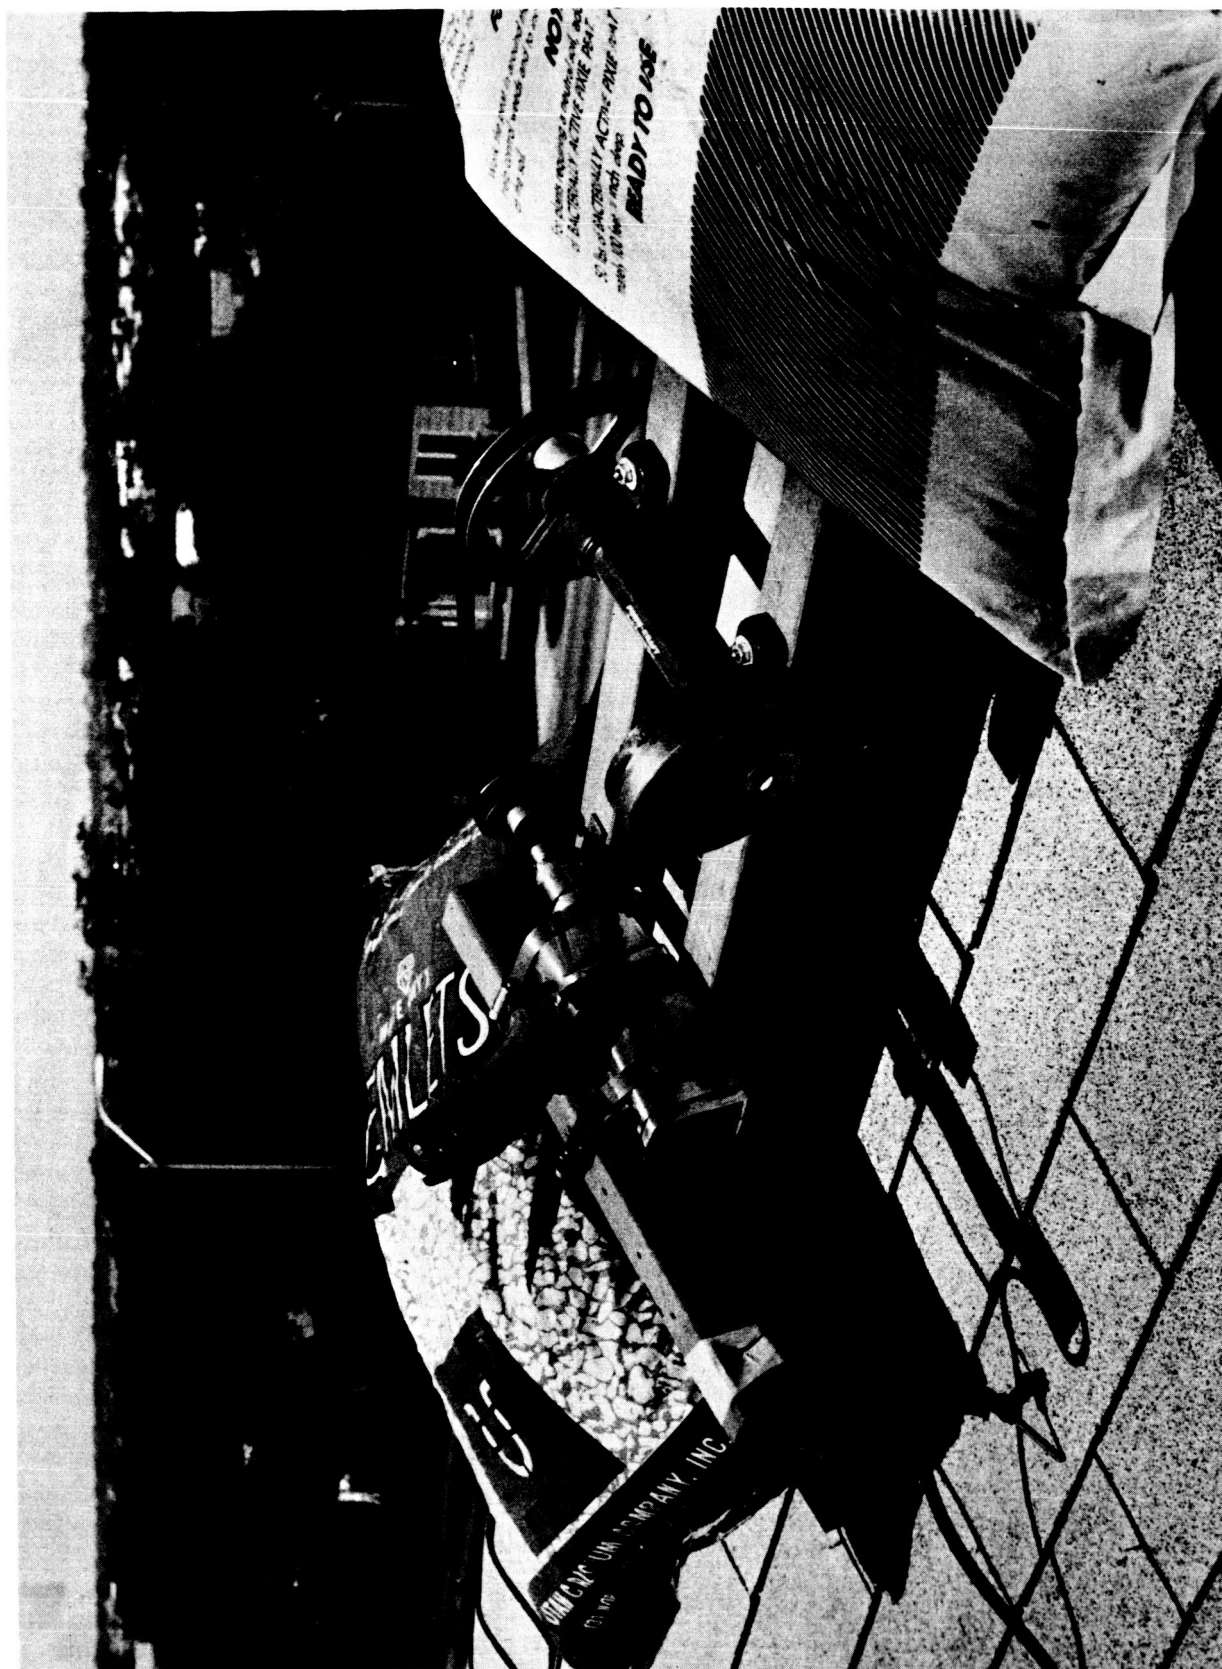
Figure 9 - Rotating eccentric device used to excite ceiling-roof structure.

A second series of tests was run in which the roof of the store was excited by a rotating eccentric. See Figure 9. The purpose of the test was to identify resonances and to verify the presence of acoustic coupling between the ceiling and windows.

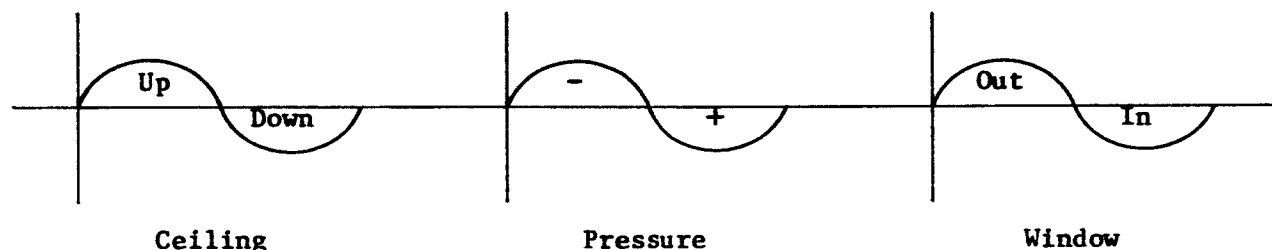
Figure 10 is an oscillogram of the ceiling motion (top trace) and the pressure (bottom trace). The phase shift present can be attributed to the velocity transducer, viz. 60 degrees lag at 8 cps. The peak displacement of the ceiling is about .0025 in. and the pressure is about .017 psf, at a frequency of 9 cps.

Figure 11 is a recording of pressure (upper trace) and window motion (bottom trace). The width of the bottom trace is due to a lack of complete filtration in the discriminator of the differential transformer. The pressure is .017 psf and the motion of the window is .006 in. at a frequency of 9 cps. Figures 10 and 11 were recorded at the same time so the values can be compared. The respective polarities of the recordings are shown in sketch below. Hence, as the ceiling moves about .0025", the pressure, in phase, is .017 psf and the window moves out .006". The motion of the center of the window would be somewhat greater, probably around .007".

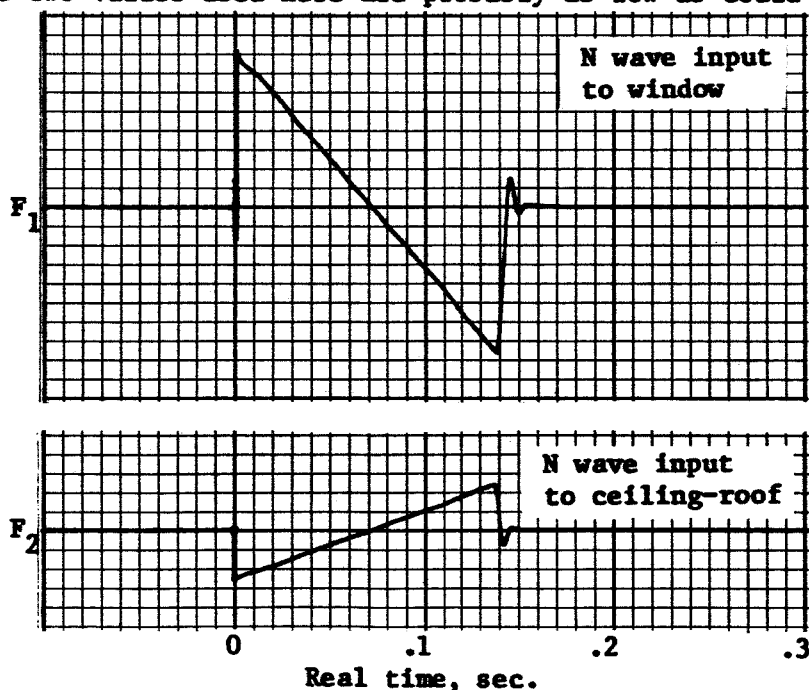
Figure 12 - N wave recordings produced for analogue computer solution.

The differential equations derived in the preceding section were solved by classical analogue techniques. The N waves were created by the integration and cut-off of a step function. The actual scaled recordings are shown in Figure 12. The over-shoot at the end of the wave is caused by the "Y" carriage of the X-Y recorder, and is a mechanical consideration only. The two waves have opposite signs since positive deflection is taken as downward roof motion and outward window motion.

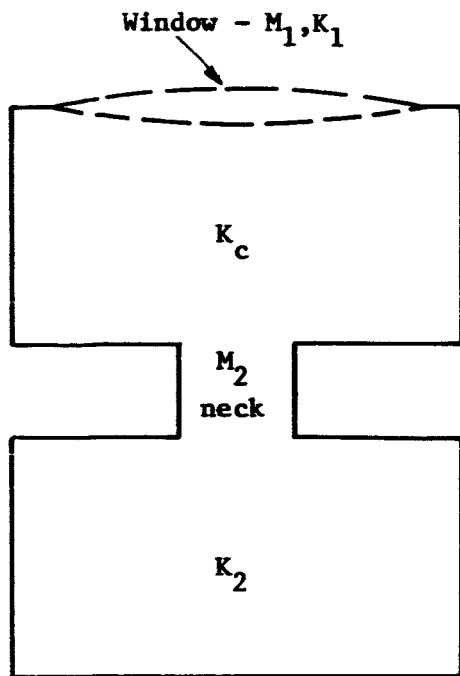
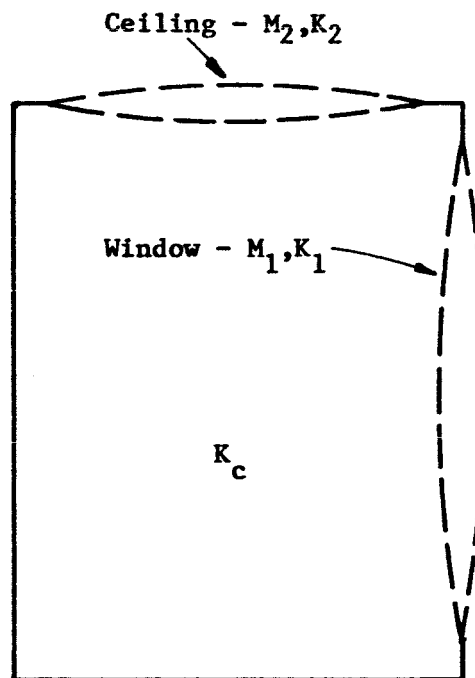
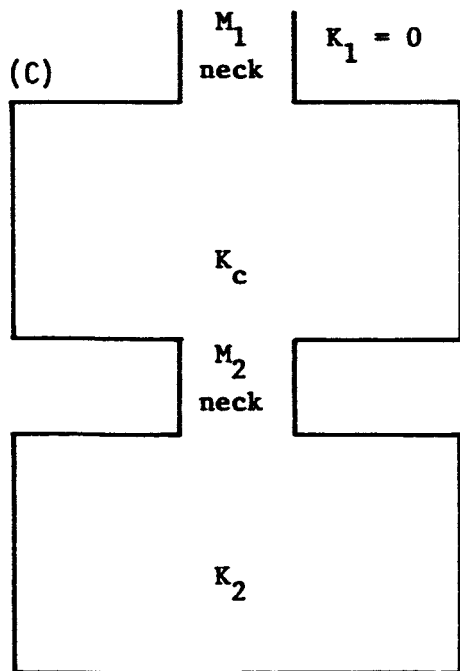
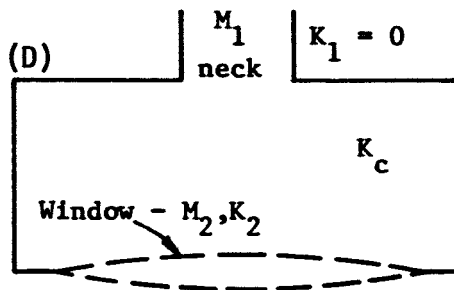
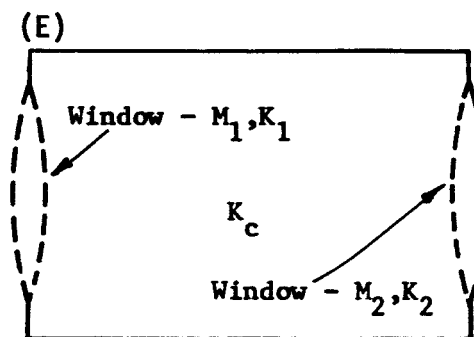
Figure 15 - Some typical structural configurations with two degrees of freedom.

While the analogue computer study was concerned with only one particular model, this representation will describe several structural configurations which are of concern in sonic boom response studies. Figure 15 shows some typical structural configurations having two degrees of freedom. All of these systems can be analyzed by the same basic model described earlier, if damping is neglected.

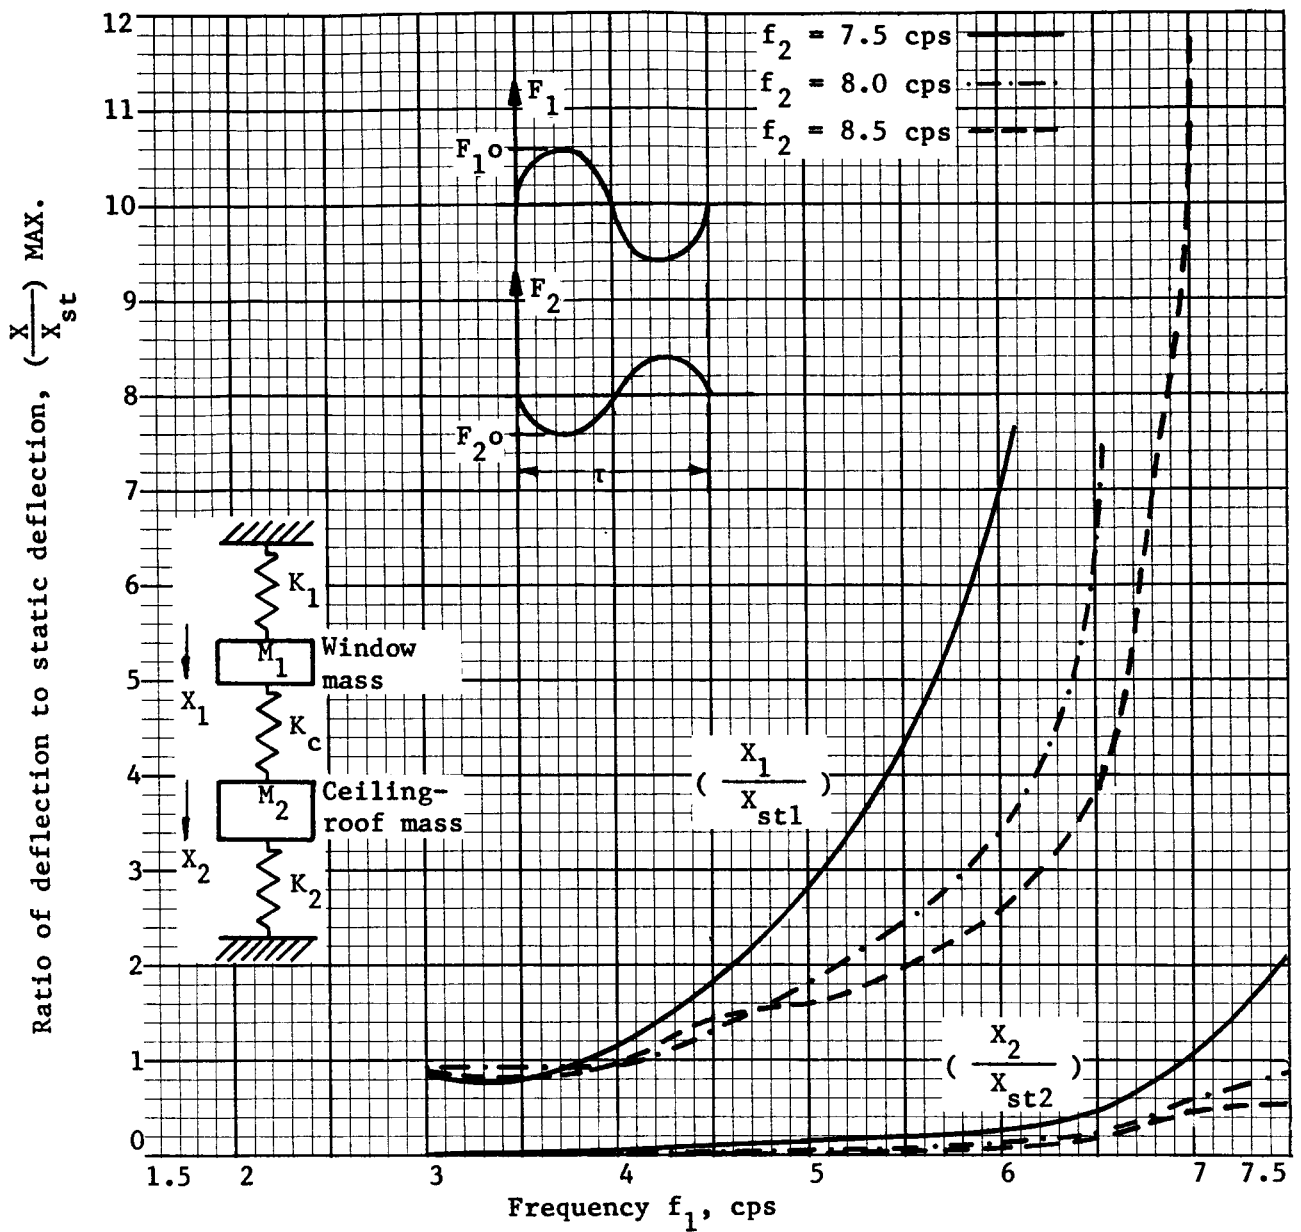
Figure 16 - Maximum response of a generalized two degrees of freedom system excited by two forces of same time duration and 180° out of phase.

Figure 16 gives maximax values of X_1/X_{st1} and X_2/X_{st2} for the case in which the forces are 180 degrees out of phase. This corresponds to the sonic boom excitation of the building since the shock wave pushes the roof downward as the windows are pushed inward. This plot indicates that large amplitudes can be expected when the two uncoupled natural frequencies are close together and the coupling frequencies are relatively low. Also, since damping is neglected in this analysis, the upper limits of the response of the system are indicated.

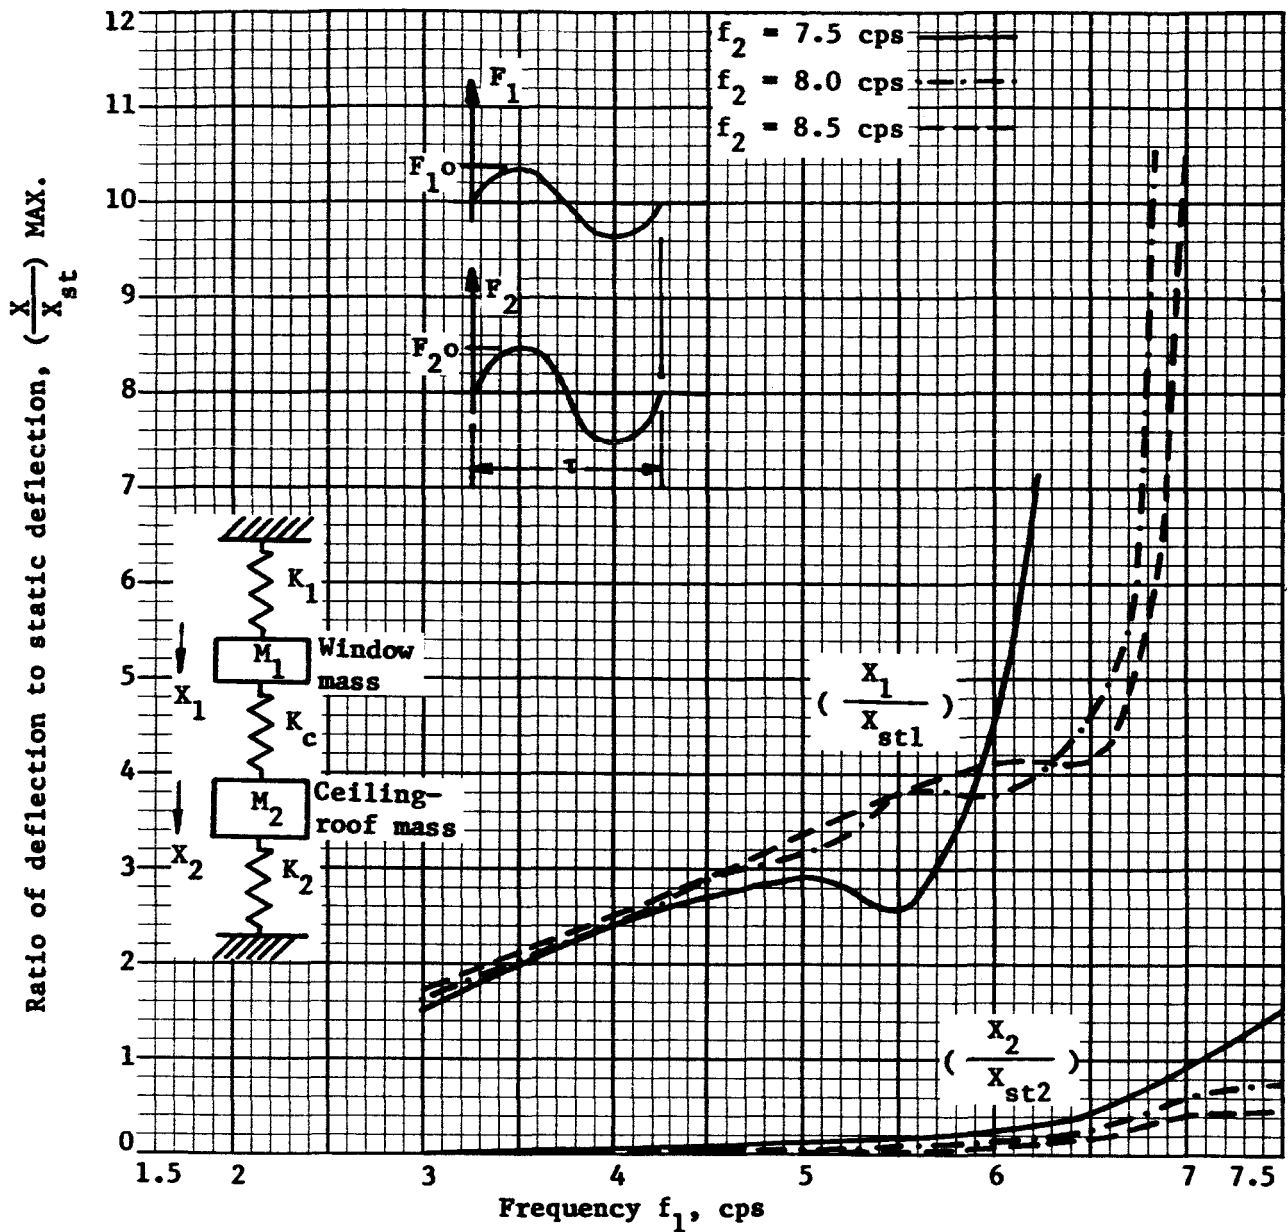
Figure 17 - Maximum response of a generalized two degrees of freedom system excited by two forces of same time duration and in phase.

Figure 17 is a plot of deflection ratios for the same system as Figure 16 except that the forces are in phase. This force configuration corresponds to a downward force of the roof and an outward force of the window. While this is opposite to the actual forcing condition, the possible condition is of mathematical interest. Since both masses are forced in the positive direction, the participation of the first mode should be strong. Also, less energy is stored in the coupling spring.

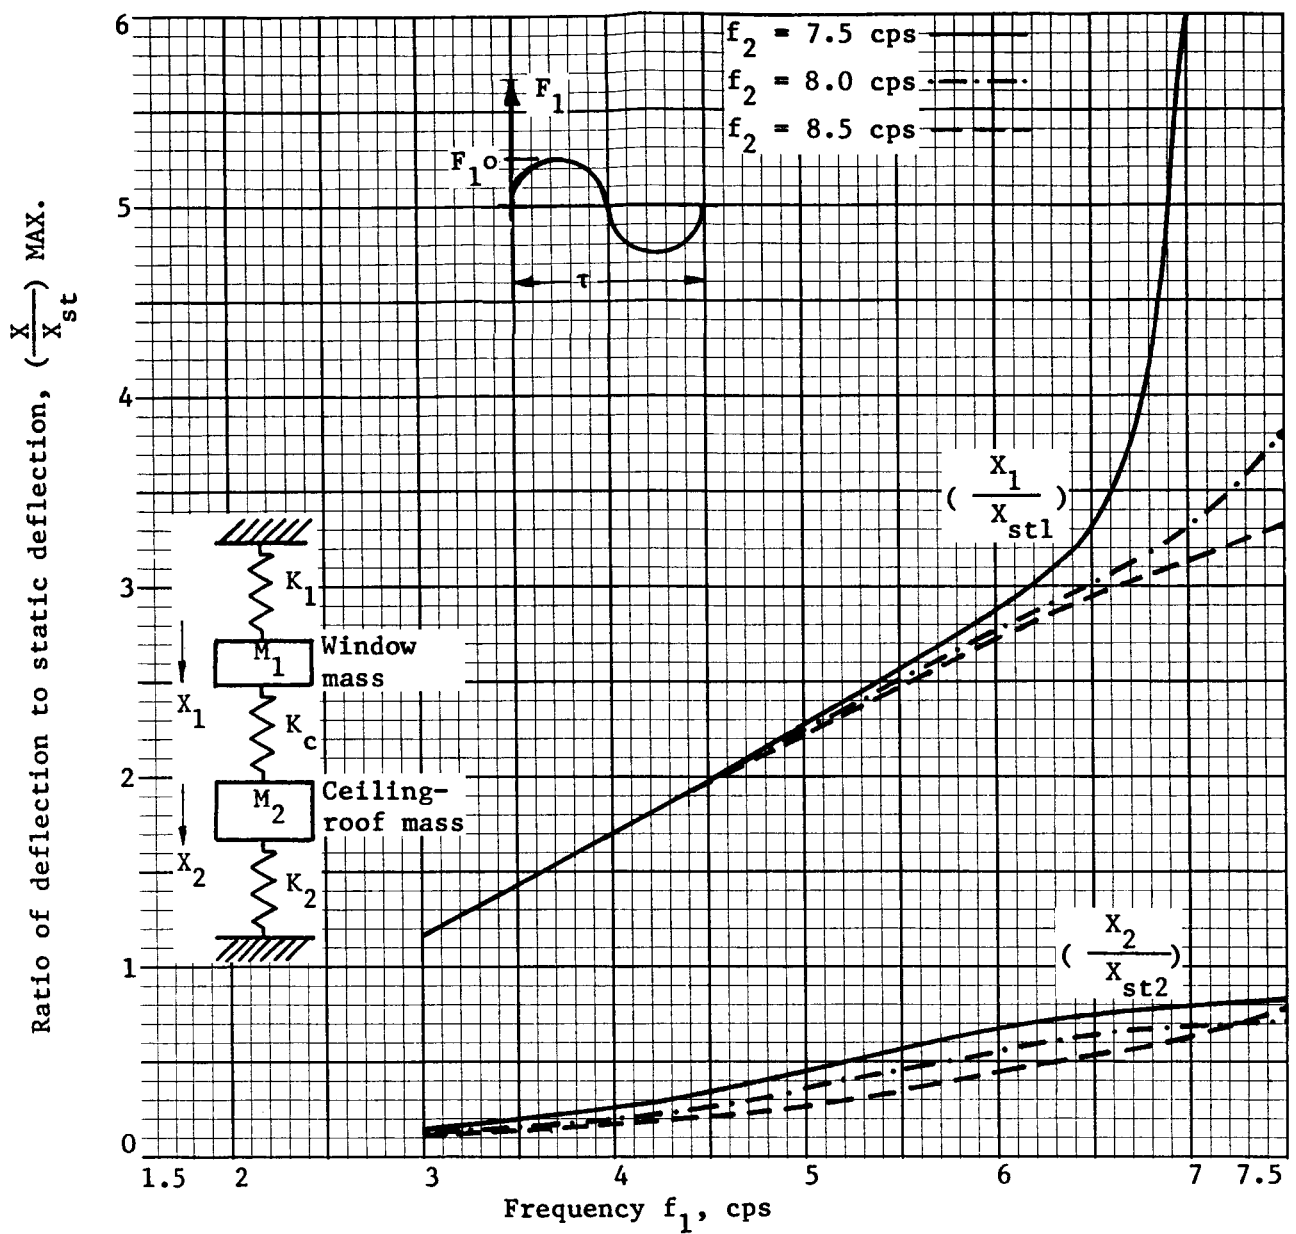
Figure 18 - Maximum response of a generalized two degrees of freedom system excited by only one force applied to one mass.

Figure 18 is a plot of deflection ratios for the same system with a force applied only to M_1 . Again this force configuration is different from that of the condition under study but does represent other possible conditions. Note that deflection ratio values for this plot range from only 0 to 6 rather than the range of 0 to 12 for Figures 16 and 17.
